BUTLER PIKE TODAY

STUDY AREA

This study focuses on a nine mile long segment of Butler Pike from the intersection with North Lane in Plymouth Township to the intersection with Limekiln Pike (PA 152) in Horsham Township. It does not include the segment within Ambler Borough, which is locally known as Butler Avenue. Butler Pike functions as a principal arterial, and it supports regional mobility between Plymouth Township, Whitmarsh Township, Whitpain Township, Ambler Borough, Upper Dublin Township, and Horsham Township. Butler Pike provides these communities with access to the PA Turnpike in Plymouth Meeting and the Fort Washington Expressway (PA 309) in Upper Dublin Township.

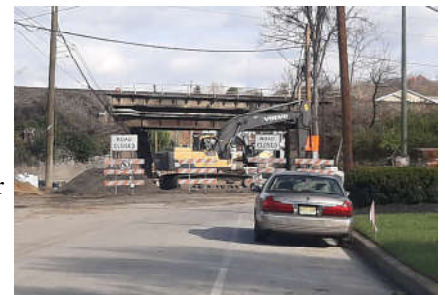
Sinkhole Remediation Project on Butler Pike

At the time of this report, projects listed on the DVRPC Transportation Improvement Program (TIP) along the Butler Pike corridor included Ridge Pike, PA Turnpike to Butler Pike (MPMS# 48175), Butler Pike over Prophecy Creek Bridge (MPMS# 98225), and Ridge Pike, Harmon Road to Crescent Avenue Reconstruction and Signal Upgrade (MPMS# 16577). The Ridge Pike corridor projects include improvements at its intersection with Butler Pike. Additionally, sinkhole remediation project between Flourtown/Plymouth Roads and Germantown Pike was completed in December 2020.

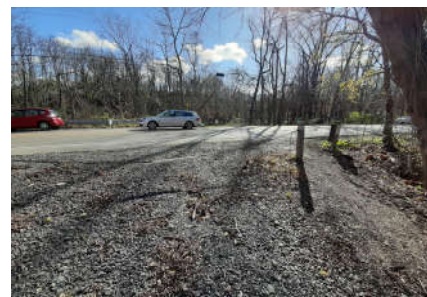
Wissahickon Green Ribbon Trail Crossing of Butler Pike

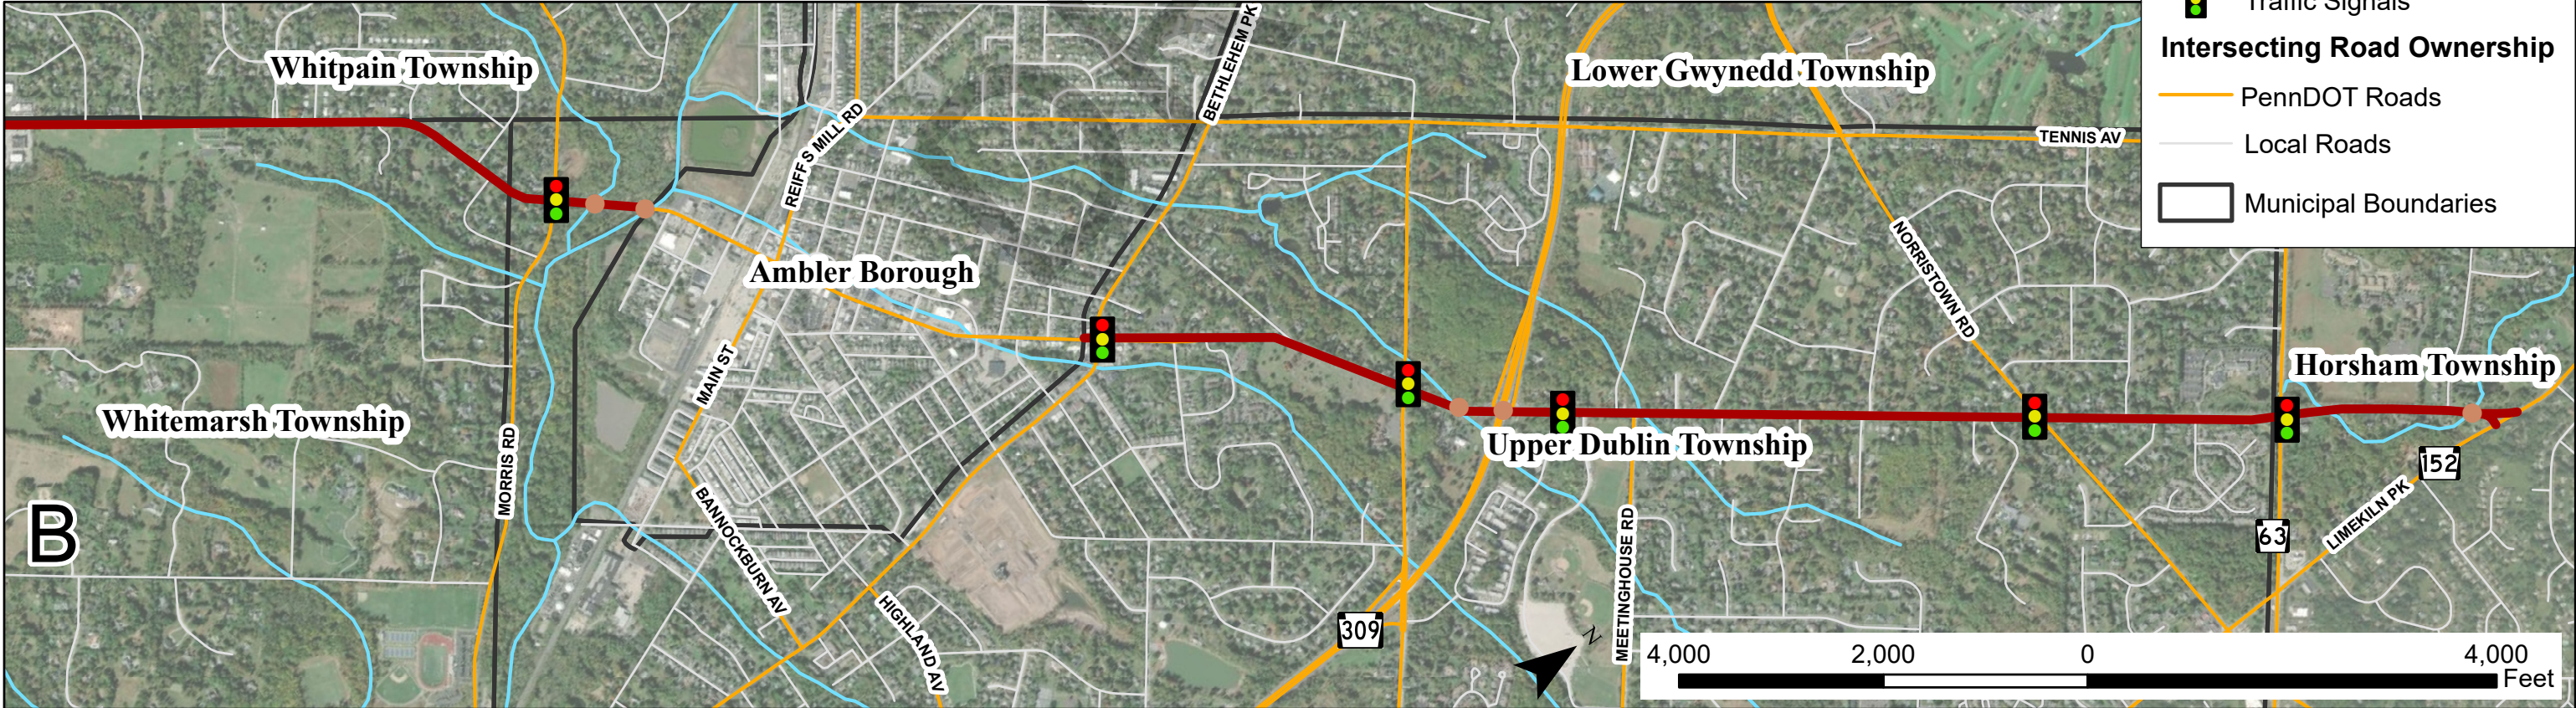
Butler Pike, Corridor Overview

There are fourteen traffic signals along Butler Pike from North Lane to Limekiln Pike. Montgomery County owns and maintains three bridge structures along this segment of Butler Pike. These bridges carry Butler Pike over Plymouth Creek in Plymouth Township and Wissahickon Creek and Prophecy Creek in Upper Dublin Township. The bridge carrying Butler Pike over Prophecy Creek has a 15 ton posted weight restriction.

These transportation features are depicted on the Corridor Overview Map.

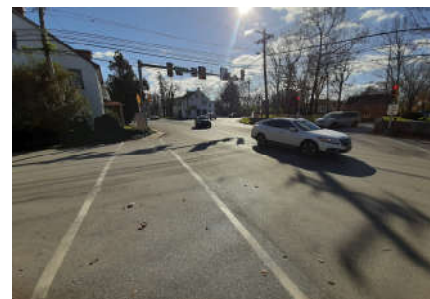
Intersection of Butler Pike and Germantown Pike

The intersection of Germantown Pike and Butler Pike is one of the most critical and challenging. Butler Pike is offset by approximately 100 feet. This, along with high traffic

volumes on both roads, has resulted in the highest concentration of crashes along Butler Pike. Additionally, this intersection is the crossroads of the Plymouth Meeting Village and is within a National Historic Register District. Community members expressed an interest in improved pedestrian connections at this intersection.

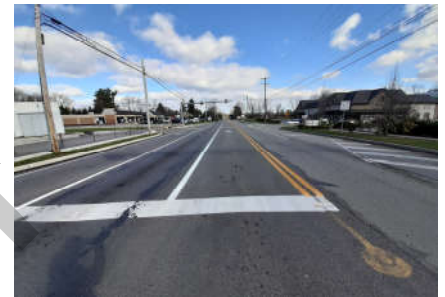
Closely Spaced Commercial Driveways Near the Intersection of Butler Pike and Skippack Pike

There are several shopping centers along Butler Pike with multiple commercial driveways or wide open driveways without proper access and traffic controls. In some areas, it is difficult to distinguish the edge of the roadway with the start of a parking lot. This impacts safety and operations for vehicular travel, as well as safety for bicyclists and pedestrians crossing the access ways.

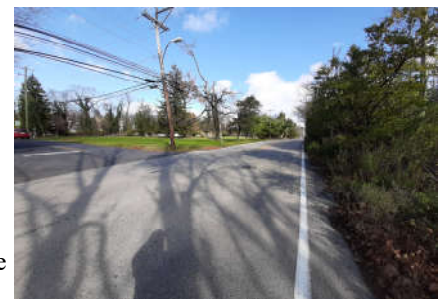
Narrow Shoulder Along Butler Pike

The urban/suburban nature of Butler Pike means that, in many areas, there is limited space to accommodate additional transportation facilities. Along many segments of the corridor, constraints outside of the county's publicly owned right-of-way, such as structures, utility poles, residential fences/decorative walls and heavily wooded and vegetated areas close to the roadway, impact the feasibility of implementing some improvements such as wider shoulders, additional travel lanes, vehicle turning lanes, on-road bicycle facilities, pedestrian facilities, or stormwater management facilities.

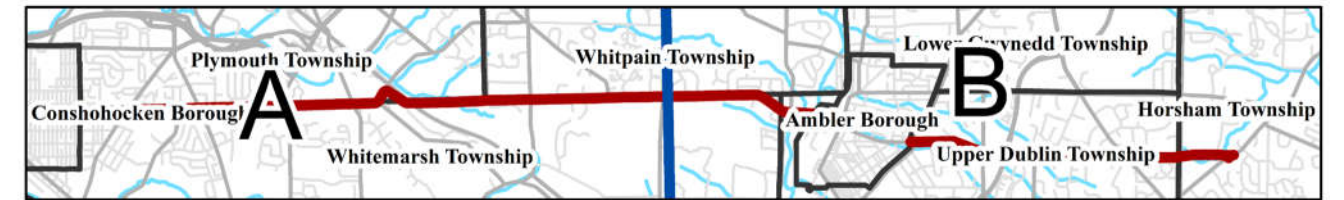
- Limited pedestrian and bicycle facilities and lack of connectivity
- Need for better bus stops, including amenities and pedestrian connections
- Poor access management for existing shopping centers
- Inadequate stormwater management
- Limited shoulders
- Closely spaced signals with the need for improved signal coordination and upgraded signal technologies

Intersection with Narcissa Road

- Intersection geometry (sharp curve, topography, and offset/stop controlled intersection) cause safety deficiencies

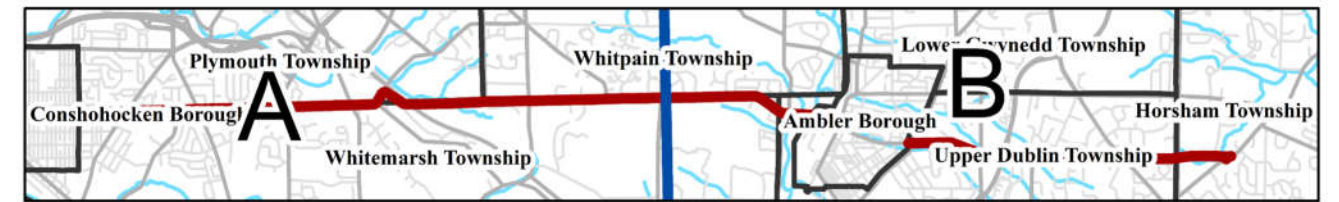
Butler Pike | Key Issues

- Corridor-Wide Issues**
- Limited pedestrian and bicycle facilities and lack of connectivity
 - Need for better bus stops, including amenities and pedestrian connections
 - Poor access management for existing shopping centers
 - Inadequate stormwater management
 - Limited shoulders
 - Closely spaced traffic signals with the need for improved coordination and upgraded signal technologies

Intersection with Morris Road

- Heavy turning movements cause operational deficiencies

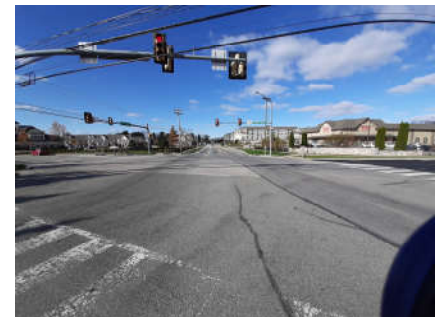
Plymouth Road/Flourtown Road Intersection, Plymouth Township

Segments between Ridge Pike and Plymouth Road/Flourtown Road intersections should be evaluated to provide a two-way center left turn lane.

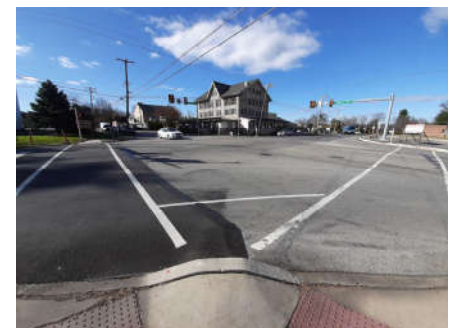
Pedestrian crossings at Skippack Pike, Whitpain Township

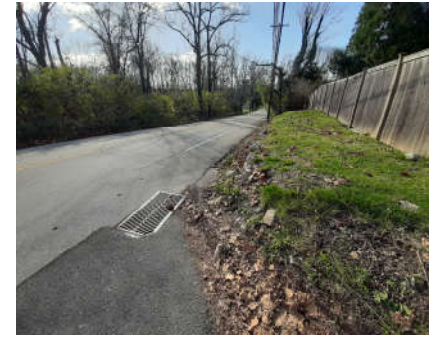
Roadside obstructions near Township Line Road, Whitpain Township

It is very common along many areas of Butler Pike for several types of obstructions to be located close to the paved cartway including areas of trees/heavy vegetation, fences, decorative walls, utility poles, and building structures.

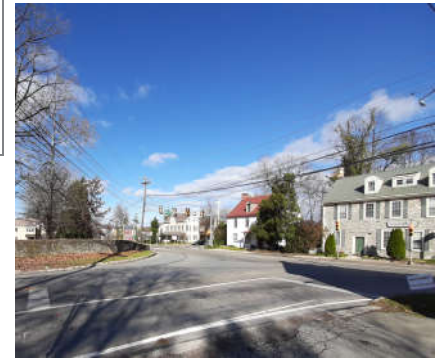
Historic resources at Germantown Pike, Plymouth and Whitmarsh Townships

Type	Corridor Constraint
Geometry	<ul style="list-style-type: none"> •Horizontal and Vertical curves between Militia Hill Road and Campus Drive •PA Turnpike overpass north of Village Way •Railroad overpass south of Plymouth Road
Environmental	<ul style="list-style-type: none"> •Karamoor Farm •Willow Lake Farm Preserve •Robbins Park •Tannerie Run Park •Rose Valley Preserve •Rose Hill Cemetery
Potential Historical	<ul style="list-style-type: none"> •Plymouth Meeting Historic District •Friends Meeting School •Cold Point Historic District •St. Matthews Cemetery near North Lane

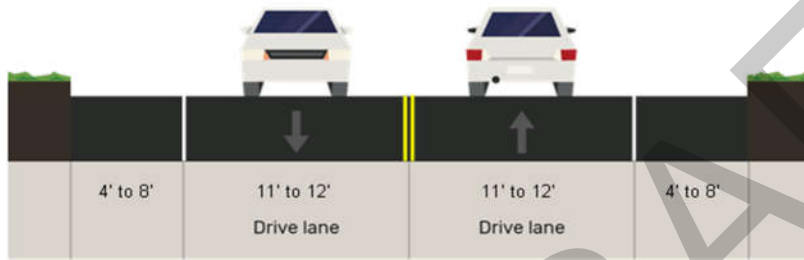
Campus Drive to Locust Street

The cross section which generally traverses the segment of Butler Pike beginning just south of the PA Turnpike overpass to the boundary of Ambler Borough will largely remain the same with improvements to the roadway to provide consistent preferred shoulder widths on both sides of Butler Pike. Sidewalks should be provided in key areas to connect closely spaced pedestrian generators. Pedestrian connections should be developed between the village of Broad Axe and the Wissahickon trail crossing.

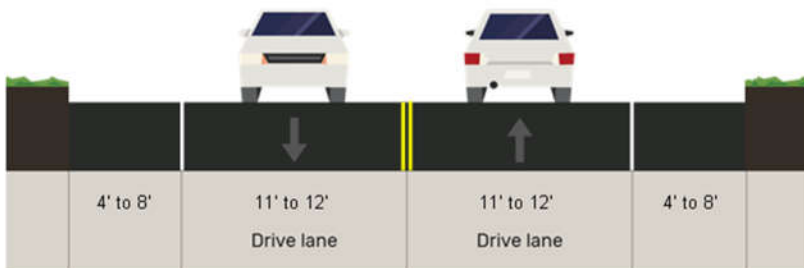
The cross section which generally traverses the segment of Butler Pike beginning at the northern boundary of Ambler Borough at Bethlehem Pike to the northern end of the corridor in Horsham Township will largely remain the same. The existing trail and sidewalk segments located on the west side of Butler Pike should be utilized to provide a shared pedestrian and bicycle facility for the entire segment. The location of the trail shown in the cross section of Bethlehem Pike to Limekiln Pike—PA 152 may need to alternate between the west and east sides of the road, with well established crossings at signalized intersections or mid-block locations, to reduce impacts to constraints and available right-of-way and easements. Since the shoulders will not be needed for bicycle use and due to the amount of roadside obstructions and constraints along this segment, a narrow shoulder can be provided at a consistent width.
