# Butler Pike | Key Issues

## Corridor-Wide Issues

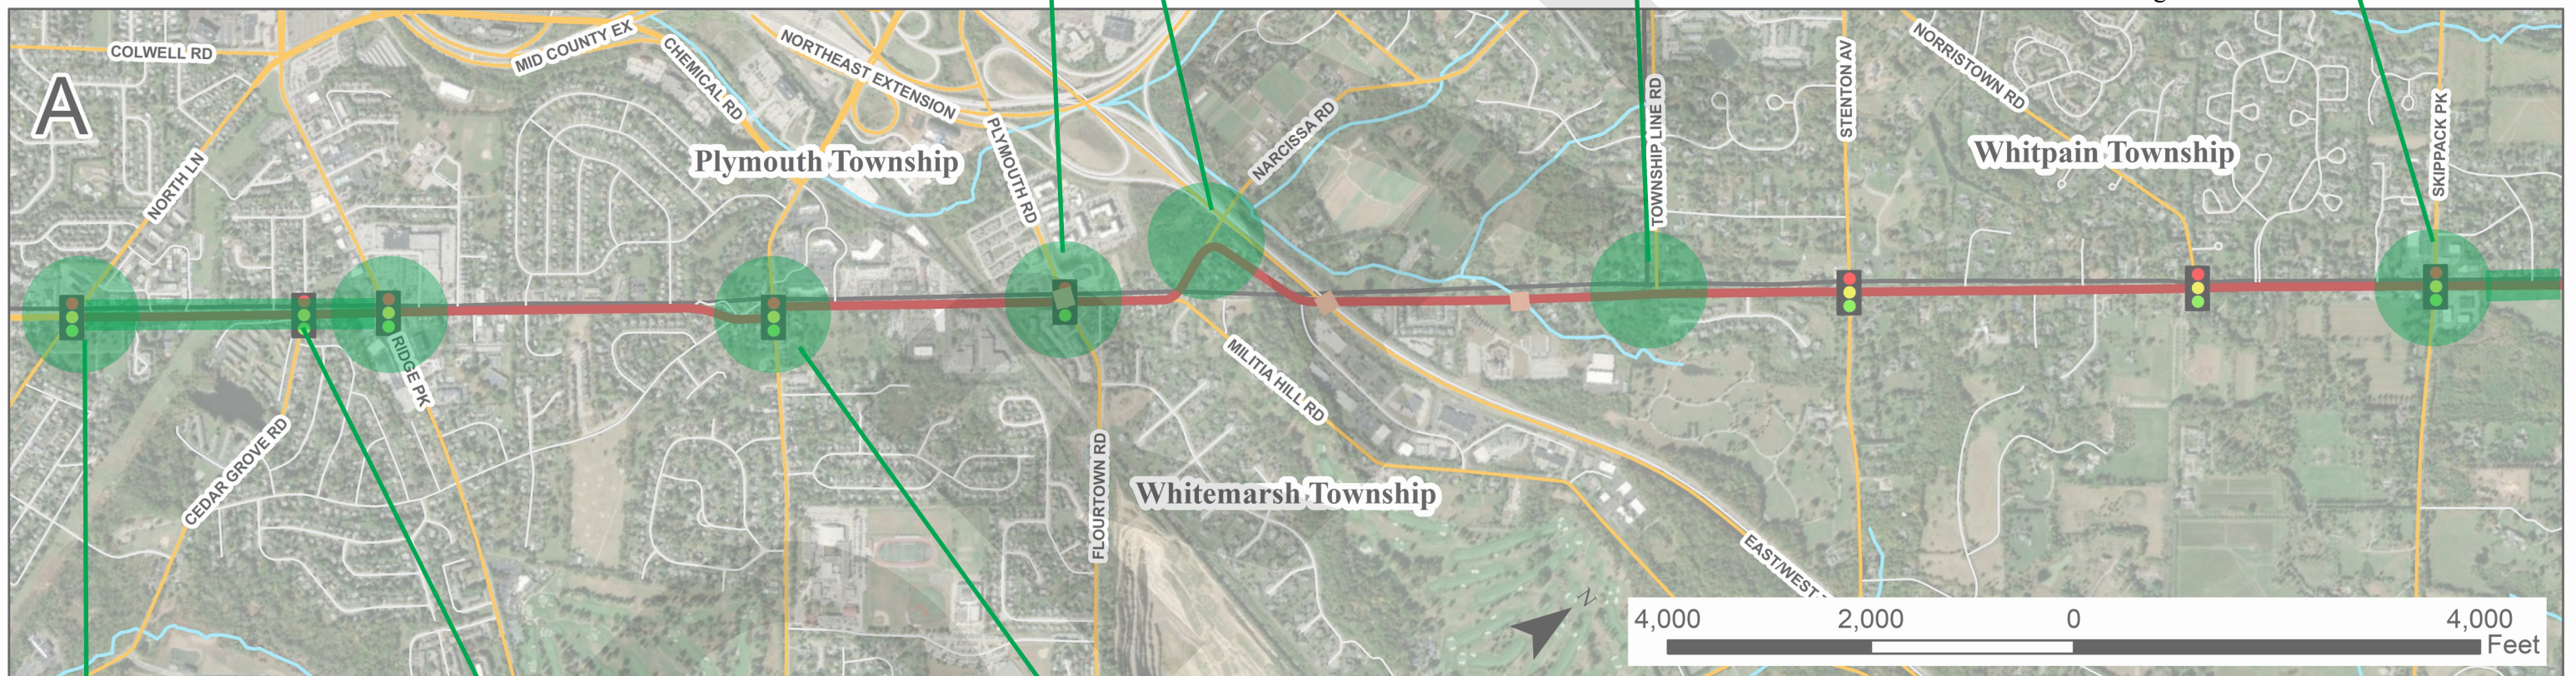
### Intersection with Narcissa Road

- Intersection geometry (sharp curve, topography, and offset/stop controlled intersection) cause safety deficiencies

### Intersection with Plymouth Road/Flourtown Road

- Capacity deficiencies

### Intersection with Township Line Road

### Intersection with Skippack Pike

- High traffic volumes and heavy turning movements cause operational deficiencies
- Lack of bicycle and pedestrian connections to Broad Axe Village

### Intersection with North Lane

### North Lane to Ridge Pike including Ridge Pike Intersection

- Lack of pedestrian connections to surrounding destinations
- Lack of bus stop amenities and pedestrian connections
- Need for signal retiming

### Intersection with Germantown Pike

- Unusual intersection geometry (offset) causes safety and operational deficiencies
- High concentration of crashes
- Congestion and capacity issues on Germantown Pike at the intersection
- Need for new/upgraded sidewalks and pedestrian crossings at the intersection
- Desire to provide a connection between Butler Pike and the Cross County Trail (at the intersection of Germantown Pike and Chemical Road)
- Crossroads within the Plymouth Meeting Village National Historic Register District with several historic resources nearby
